Grade:
4.1 Clean

2014 MERCEDES GL450 4MATIC GL450

VIN 4JGDF7CE0EA308461
 Ext Color BLACK- 040
 Work Order 5597148
 Sale Number 5
 CR Date 12/11/2019

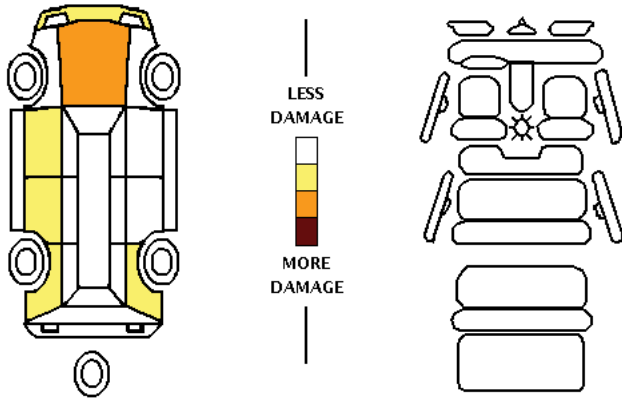
Condition Heat Map

Cosmetic Conventional Paint and Body Not Required-[4 Items]

IMAGE	DESCRIPTION	CONDITION	SEVERITY
	L Qtr Panel	Dent/No Paint Dmg	PDR/1
	LF Door	Dent/No Paint Dmg	PDR/1
	LR Door	Multi Dents/No Paint Dmg	PDR/3
	R Qtr Panel	Dent/No Paint Dmg	PDR/1

Paint and Body Requires Conventional Repair-[2 Items]

IMAGE	DESCRIPTION	CONDITION	SEVERITY
	Front Bumper Cover	Scratch Heavy	2" to 3"
	Hood	Scratch Heavy	GR 12"
