2014 MERCEDES ML550W4 ML550

VIN 4JGDA7DB1EA276641
 Ext Color WHITE- 799
 Work Order 6440556
 Sale Number 6
 CR Date 01/10/2020

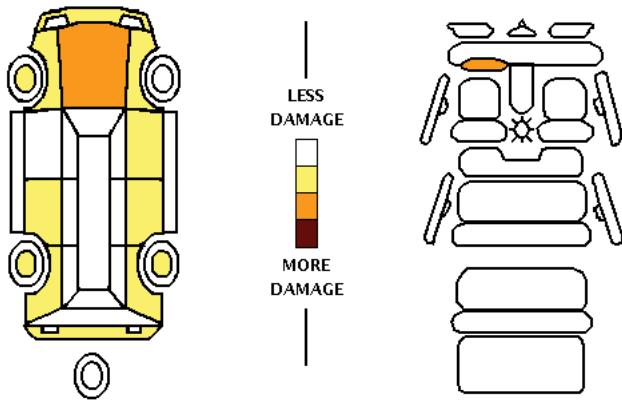
Condition Heat Map

IMAGE	DESCRIPTION	CONDITION	SEVERITY
	L Qtr Panel	Dent/No Paint Dmg	PDR/1
	R Qtr Panel	Mult Dents/No Paint Dmg	PDR/3

IMAGE	DESCRIPTION	CONDITION	SEVERITY
	Front Bumper	Prev Repair	Acceptable
	Hood	Replaced	Acceptable
	LF Fender	Prev Repair	Acceptable
	LR Door	Prev Repair POOR PDR	Acceptable
	Rear Bumper	Prev Repair	Acceptable
	RF Door	Prev Repair	Acceptable
	RF Fender	Prev Repair	Acceptable
	RR Door	Prev Repair	Acceptable

IMAGE	DESCRIPTION	CONDITION	SEVERITY
	Emissions Sticker	Missing	Replacement Required
	F Valance	Dent/No Paint Dmg	1/2" to 1"
	LF Wheel	Curb Rash	GR 12"
	LR Wheel	Curb Rash	7" to 8"
	Owners manuals	Missing	Replacement Required
	RR Tire	Worn	Replacement Required
	RR Wheel	Curb Rash	GR 12"
	Warning - Engine	Inop	
	Warning - Engine	On	Unacceptable
	Warranty Books	Missing	Replacement Required
