2016 Audi Q5 quattro 4dr 2.0T Premium Plus

WA1L2AFP6GA117534 • 97,720mi

Damage Overview

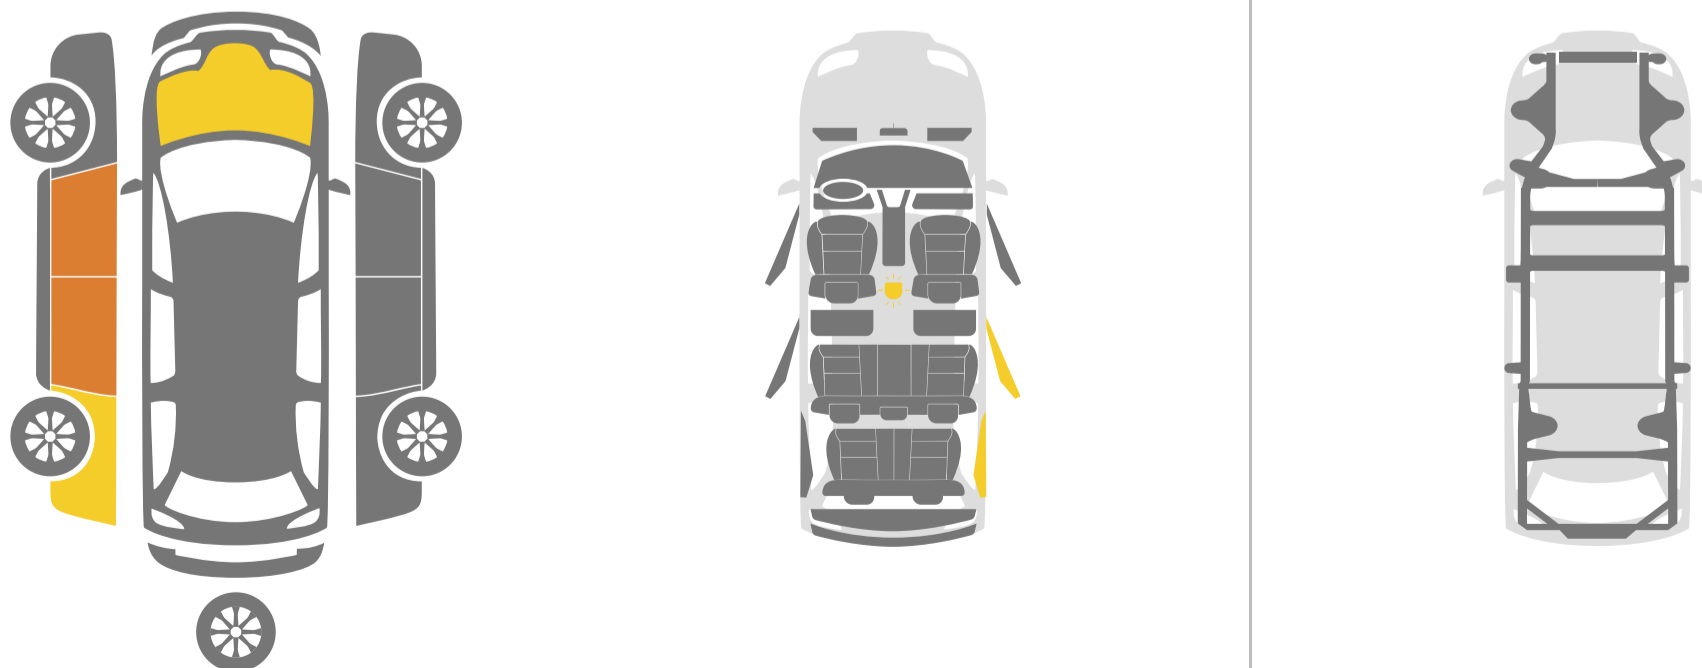
Description	Condition Severity	Type	Image	Additional Info
● Front Bumper Cover	Bug Damage Acceptable	Miscellaneous		
● Hood	Chipped 10 or More	Paint and Body Requires Conventional Repair		
● LF Door	Dent/Paint Dmg 1/2" to 1"	Minor Damages Conventional Repairs May Be Required		
● L Qtr Panel	Mult Dents/No Paint Dmg PDR/2	Cosmetic Conventional Paint and Body Not Required		
● LR Door	Mult Dents/Paint Dmg 3	Paint and Body Requires Conventional Repair

● Right Interior "C" Pillar Trim	Stained Permanent	Miscellaneous

Description	Condition Severity	Type	Image	Additional Info
● Owners manuals	Missing Replacement Required	Miscellaneous		
● Warranty Books	Missing Replacement Required	Miscellaneous		
● Headliner	Stained Permanent	Interior
