### 2016 Audi Q5 quattro 4dr 2.0T Premium Plus

WA1L2AFPOGA012794 • 93,098mi

AUTOGRADE  
**3.6**  
Average

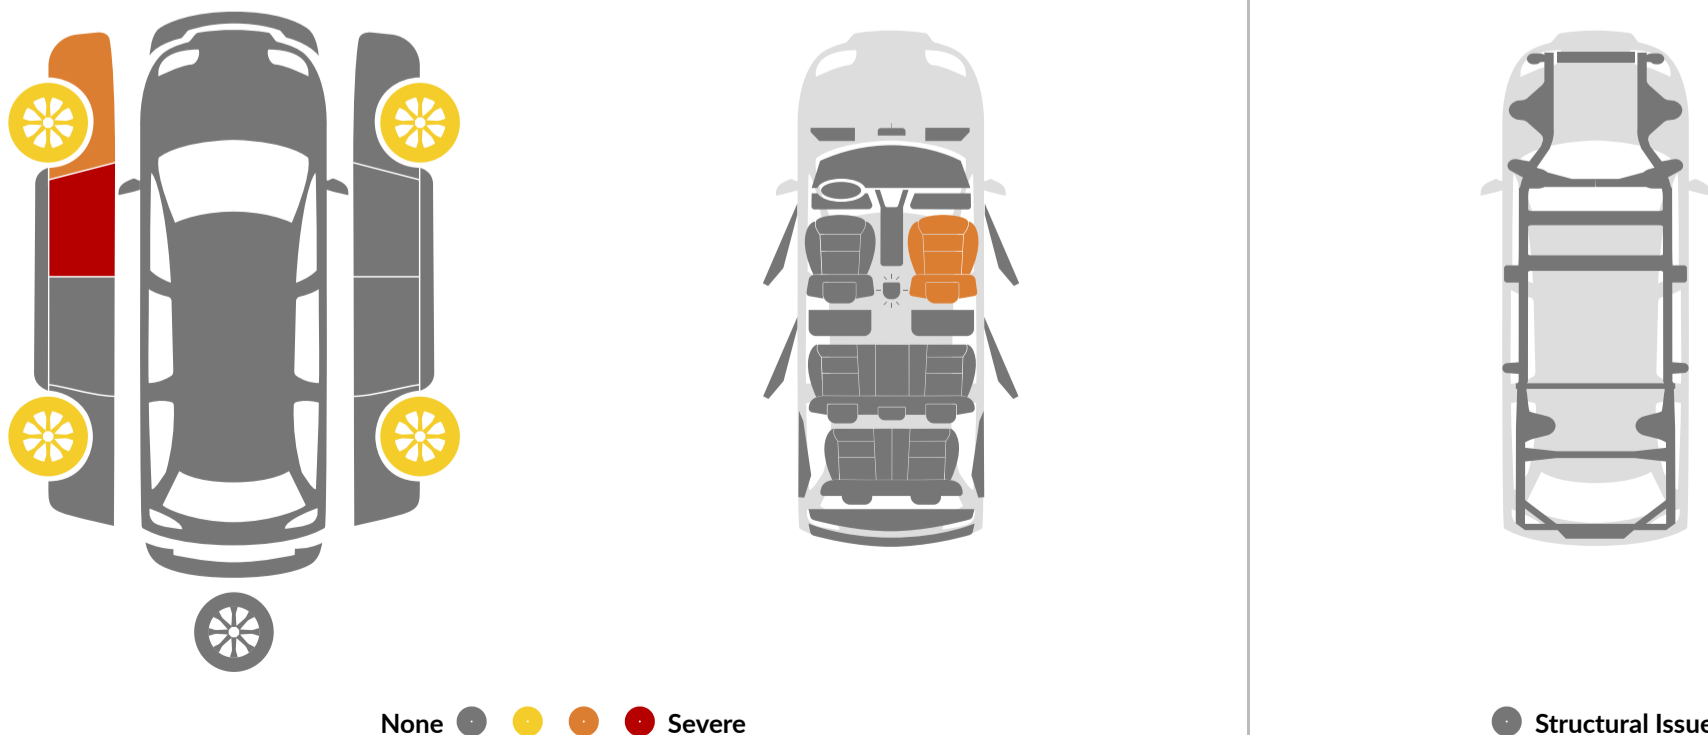
#### Damage Overview

Description	Condition Severity	Type	Image	Additional Info
● <b>LF Door</b>	Mult Dents/Paint Dmg 10 or More	Paint and Body Requires Conventional Repair

poor pdr
● <b>LF Fender</b>	Mult Dents/No Paint Dmg 2	Minor Damages Conventional Repairs May Be Required

● <b>LF Wheel</b>	Curb Rash 8" to 9"	Miscellaneous		
● <b>LR Wheel</b>	Curb Rash 1" to 2"	Miscellaneous		
● <b>RR Wheel</b>	Curb Rash 1" to 2"	Miscellaneous		
● <b>RF Wheel</b>	Curb Rash 1" to 2"	Miscellaneous

Description	Condition Severity	Type	Image	Additional Info
● <b>RF Seat</b>	Torn 1/8" to 1/2"	Interior
