2018 Mercedes-Benz C-Class C 300 Sedan

55SWF4JBXJU251657 • 17,169mi

AUTOGRADE
4.1
Clean

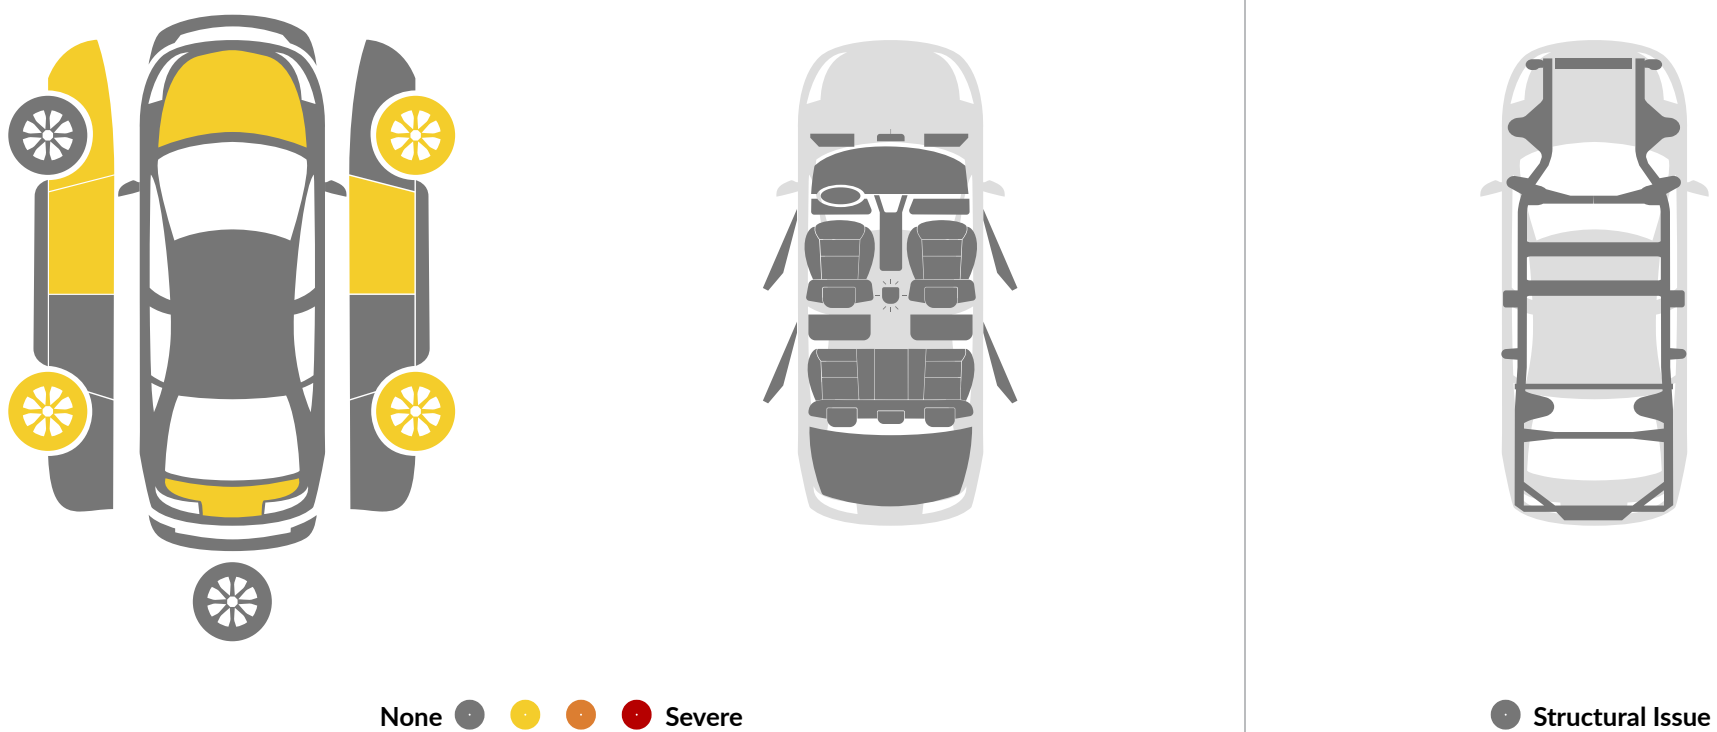
Damage Overview

Exterior (9)

Description	Condition Severity	Type	Image	Additional Info
● Front Bumper Cover	Prev Repair Acceptable	Miscellaneous		
● Hood	Prev Repair Buffable	Previous Repair		
● LF Door	Prev Repair Acceptable	Previous Repair

Description	Condition Severity	Type	Image	Additional Info
● LF Fender	Prev Repair Acceptable	Previous Repair		
● LR Wheel	Curb Rash 11" to 12"	Miscellaneous		
● Deck Lid	Prev Repair Acceptable	Previous Repair		
● RR Wheel	Curb Rash 11" to 12"	Miscellaneous		
● RF Door	Dent/No Paint Dmg PDR/1	Cosmetic Conventional Paint and Body Not Required		
● RF Wheel	Curb Rash 4" to 5"	Miscellaneous
